# The Hull floods of 2007: implications for the governance and management of urban drainage systems

T.J. Coulthard and L.E. Frostick

Department of Geography, University of Hull, Hull, UK

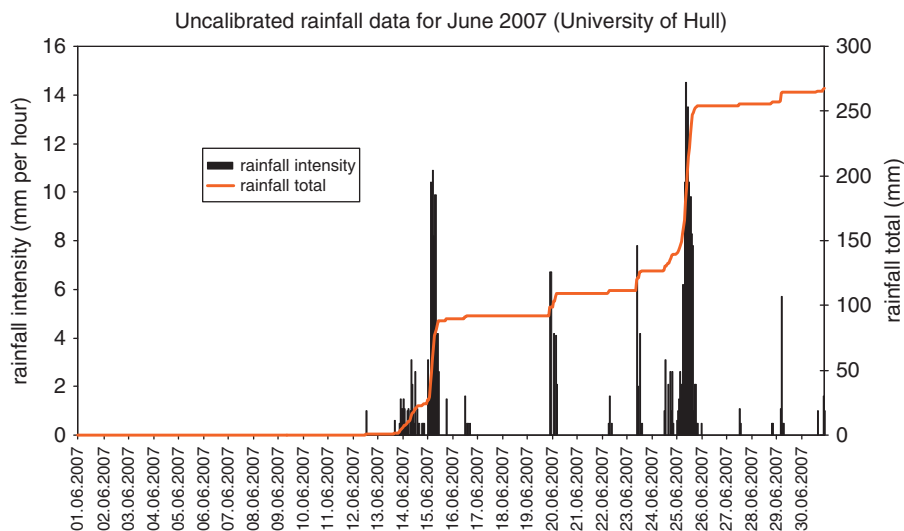
**Figure 3** Rainfall for June 2007. Data from an uncalibrated rain gauge on the Cohen Building, University of Hull.

brated rain gauge at the Geography Department, University of Hull, recorded 110 mm on 25 June and over 250 mm in the month (Figures 3 and 4). On the 25th, Figure 4 shows that the rainfall was heavy and sustained, with intensities of over 6 mm/h between 8 a.m. and 5 p.m. There are no local records of soil moisture or groundwater levels in Hull, but it is likely that there was high antecedence following a rainfall event on 15 June (itself > 1 in 30 recurrence) that also caused some local flooding. The return period of the 25 June event was estimated at 1 in 150 years (CEH Flood Estimation Handbook, Yorkshire Water pers. comm.) and > 1 in 200 years (Hanna *et al.*, 2008).

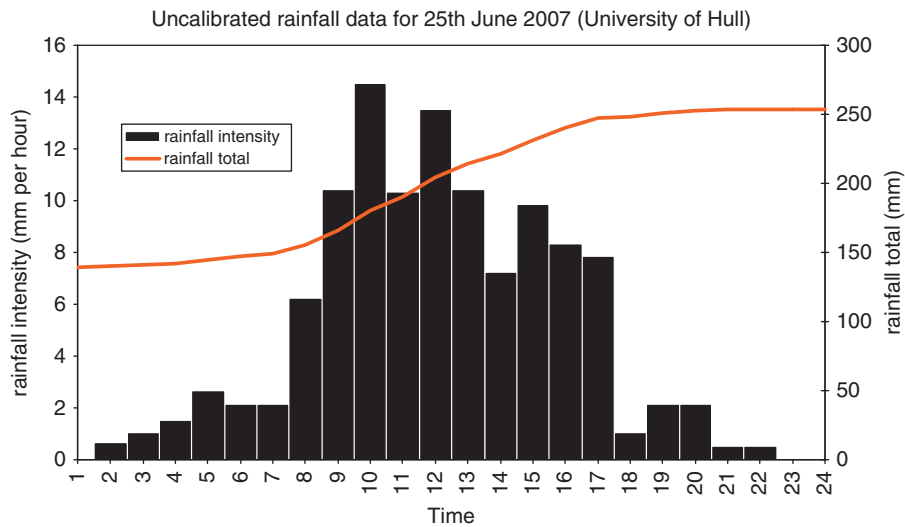
Figure 4 Rainfall for 25 June 2007. Data from an uncalibrated rain gauge on the Cohen Building, University of Hull.

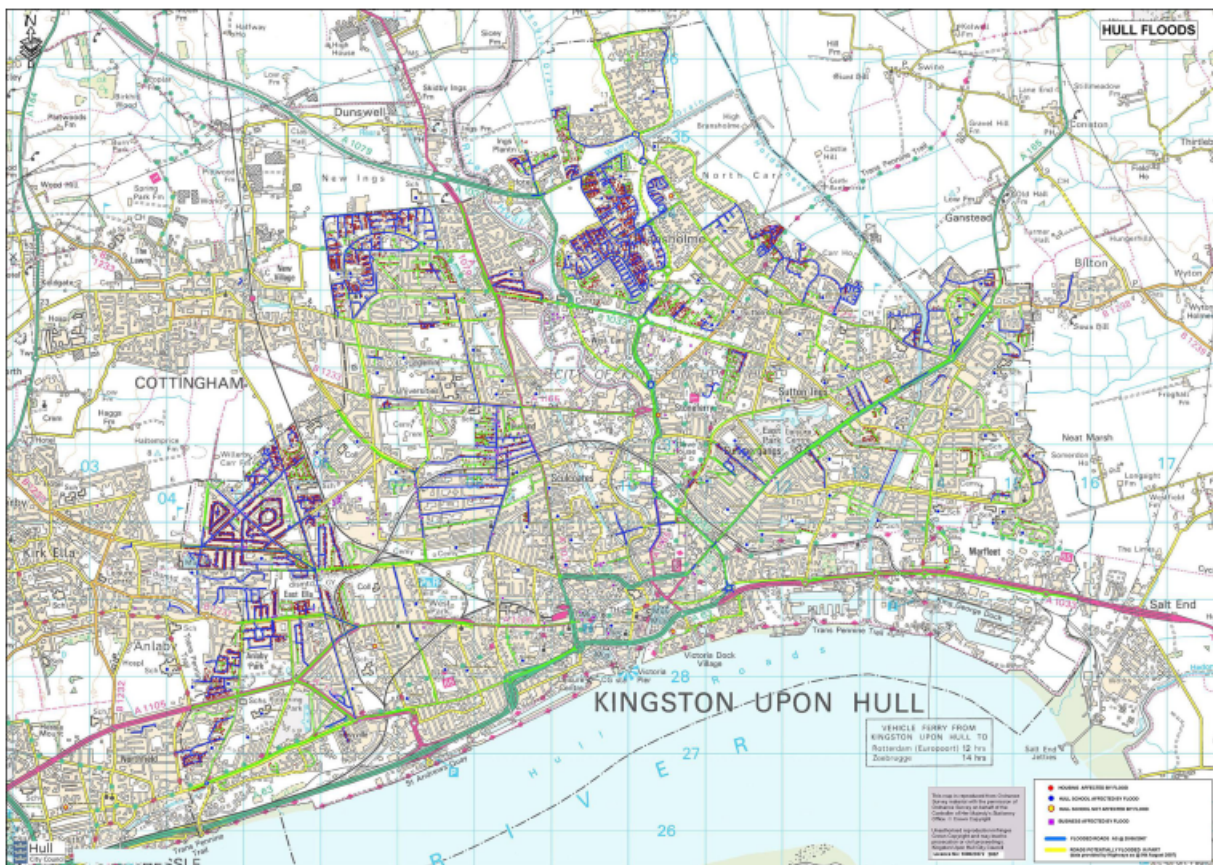
Figure 5 Areas in Hull flooded. Lines correspond to flooded roads and dots show flooded properties.

Analysis of the spatial distribution of flooding shows that in East Hull, the problems were largely concentrated around the Bransholme and Kingswood areas that are served by their own pumping station. Inundation was more widespread in West Hull, with large areas of Orchard Park (north), Newland Avenue and the Avenues (north/central), Priory Road/East Ella and Anlaby Park (west) flooded. There is a partial correlation between the areas flooded (Figure 5) and elevation (Figure 1), with the lowest areas being among those inundated. But flooding was not restricted to the lowest areas of Hull, suggesting that factors other than topography were also controlling flooding.
